# Welcome to Your Reserve Study The Gardens at Heritage Green

Chattanooga, TN

Date of Inspection: 2-26-24

Level of Study: 1 (Full Reserve Study)

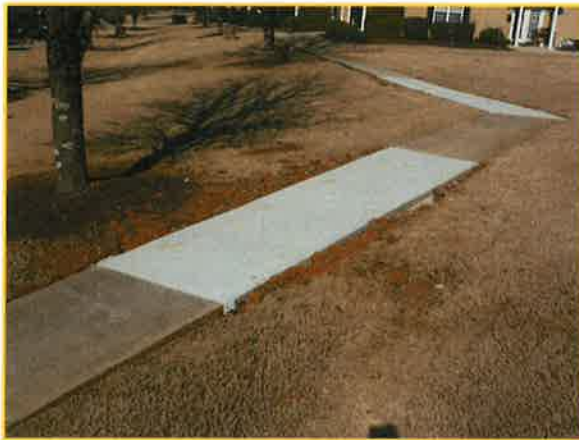
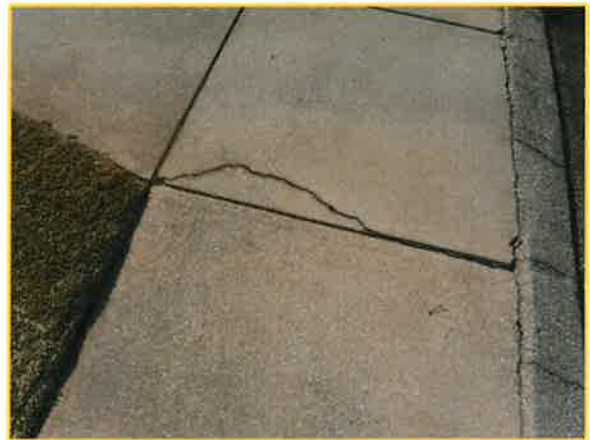
**Component #:** 103 Concrete Sidewalks – Partial Repair

Analysis: Conditions vary by location. There is no expectation to replace all concrete at once. Funding for periodic repairs as the concrete ages. Adjust as future conditions dictate. Association has a history of partial repairs where most urgently needed. Expectation is for this continue. Cracks and lifting observed in numerous areas and are addressed for repairs regularly.

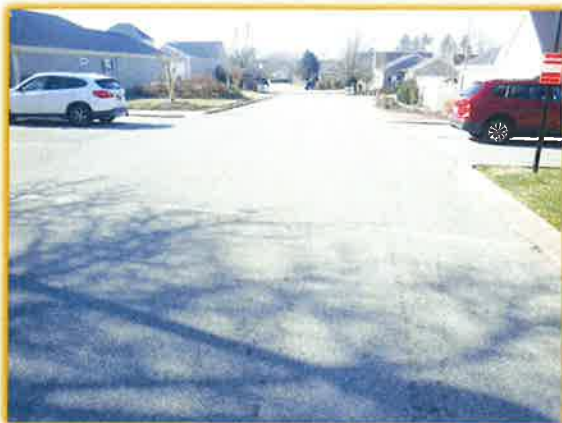
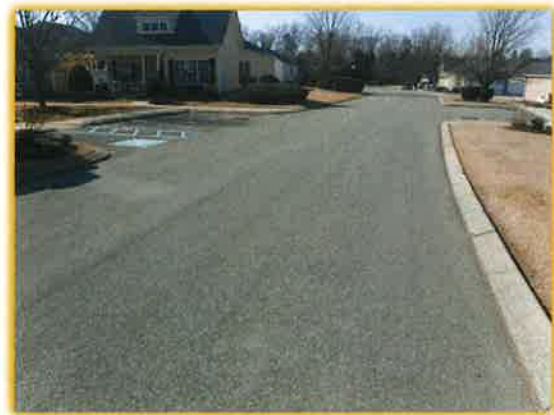
**Component #:** 201 Asphalt - Remove & Replace

Analysis: If sealed regularly (every 5 years), and partial resurfacing is done as needed when small areas of deterioration occur, this surface should easily reach the expected Useful Life of 25 years. Failure to do the regular sealing is likely to shorten the life-span of the roadway. Currently, the road is in fair condition but will benefit from another seal project in 2026. It is currently unclear whether this private road will be regularly maintained by the city or if the association will need to be prepared to handle the projects in order to maintain the high aesthetic value the community enjoys.
